Framus Guitar Restoration

2nd March 2015

JW Luthier Services

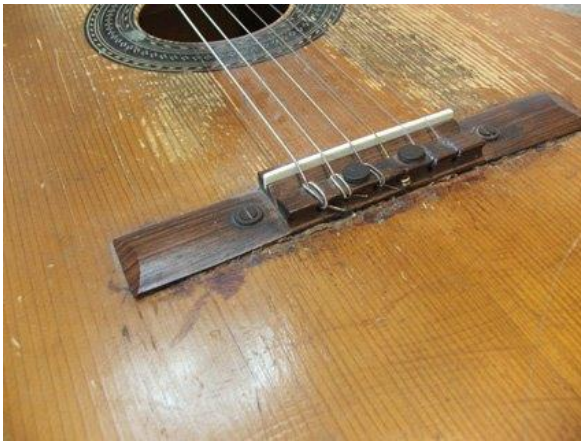
Photo 1.

In some distant past it had been restrung with steel strings instead of nylon.

The catastrophic result was that the top buckled & detached in places, one of the braces inside snapped & most of them broke away from the top. Also the bridge lifted & pinged off.

Someone had tried to glue and bolt the bridge back on (very badly) but the instrument was virtually unplayable.

Here you can see that the detached bridge had been glued and bolted back in place, but it no longer conformed to the contour of the top. Also evident are the areas of deep wear above and below the strings.

The old bridge was in too bad a shape to be re-used and so I made a new replica one from Rosewood. I copied the original but added 1.5mm to the height so that I could add a little more strength to the wings which had distorted upward on the original. It also allowed me to reduce the saddle protrusion above the bridge which had been a little excessive on the old one.

I located the bridge in the exact position of the original by utilising the two bolt holes that had been added during the earlier attempted repair. A mother-of-pearl strip hides the new screws.

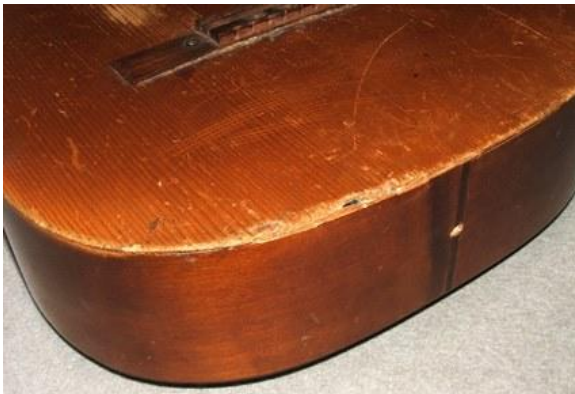
Photo 2.

The top had been pulled away from the sides in several places and damaged.

An attempt had been made to glue it back down, but generally this had not been successfully achieved.

The strap end-pin is missing also.

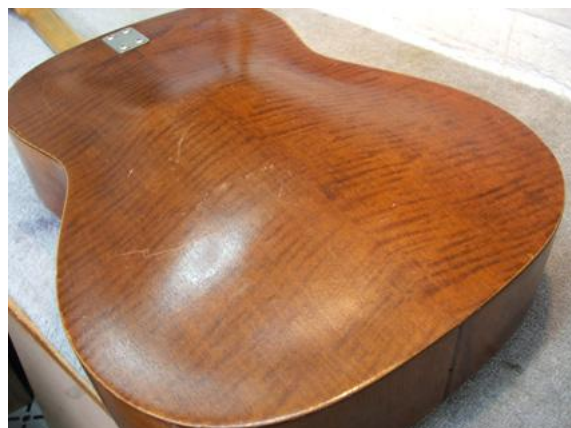
Photo 3.

The back and sides were in a reasonable condition apart from a few scratches and a forty year accumulation of dirt. There was no structural damage to be concerned about.

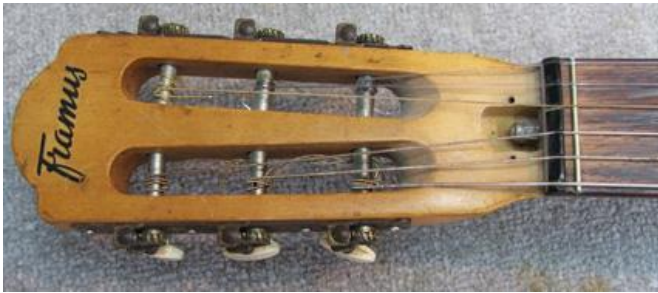
Photo 4.

The neck was in good condition for the age, just a bit dirty. The steel strings had worn down some of the frets and the fingerboard had some very slight wear indentations too. Unusually for a nylon strung guitar it was fitted with a truss rod. The adjuster nut needed a bit of freeing up and lubricating but was otherwise OK. The original truss-rod cover was missing.

The neck and fingerboard needed a good clean plus a fret level/dress & polish. I made a new truss-rod cover from Rosewood to replace the missing original. From the discolouration of the original finish I could see the outline of the missing part and so made the new one to the same shape. The remainder of the appearance was just done from my imagination. A couple of mother-of-pearl dots were inlaid for embellishment and a pair of nickel screws secured it into the existing fixing holes in the head.

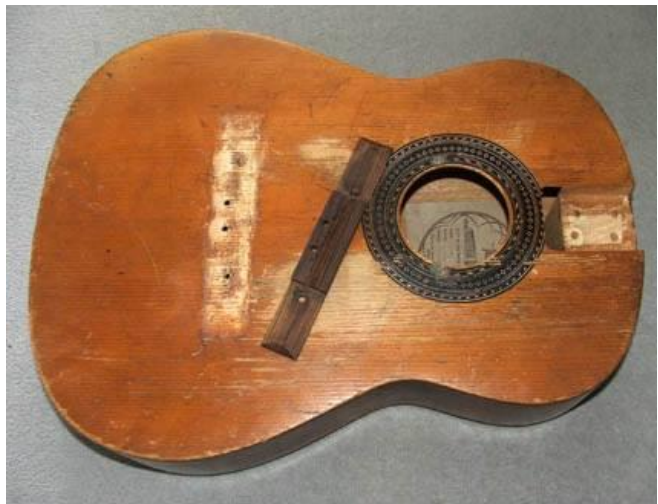
Photo 5.

After taking out the bolts and screws I wasn't too sure how well it would come off. I suspected that the glue used was not the usual types associated with guitar construction and so might prove difficult.

I started by removing the bridge.

Luckily though, as it wasn't seated very well, I was able to get a heated spatula underneath it after warming the bridge to soften the glue a bit.

A few minutes of careful probing with the spatula popped it off quite cleanly.

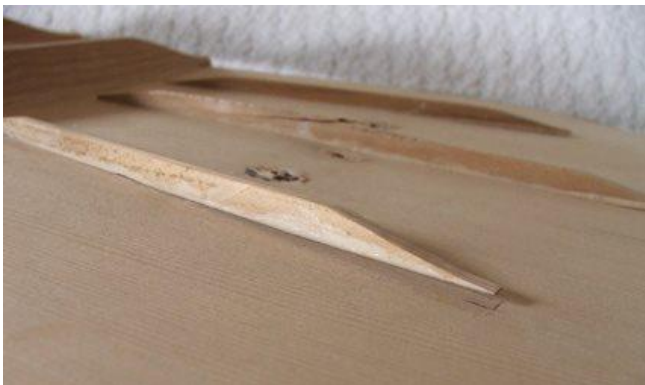
Photo 6.

This was when I discovered that the instrument had originally been French polished. I hadn't been too sure up to this stage, but when I warmed the top to soften the glue for removal it caused the finish to soften also and my workshop was filled with the distinct aroma of French polish (which I rather like!).

Next I removed the top so that I could get a good look at the brace damage.

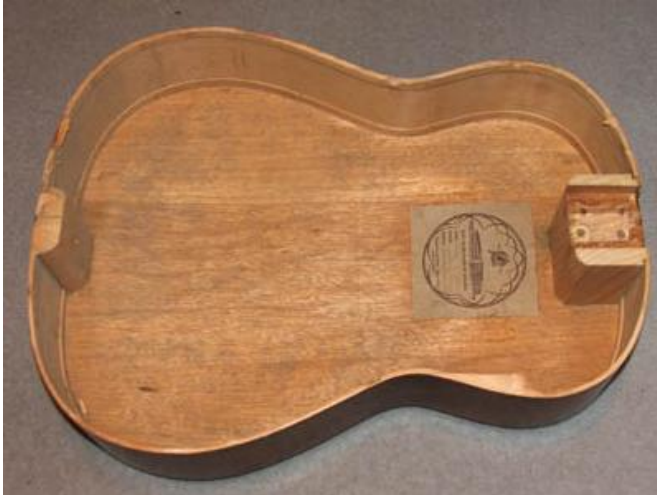
Photo 8.

With the top off I was able to get a closer look at the faded label.

I could just make out the date code which was 73E (May 1973) and the serial number 01054.

Unfortunately the model name / number and the Inspectors signature were too faded to read. The signature is likely to be that of Richard Muller who I believe was the Framus master guitar-maker and final inspector around that time.

Before continuing I cleaned up the edge to get rid of the old glue and broken remnants ready to accept the top.

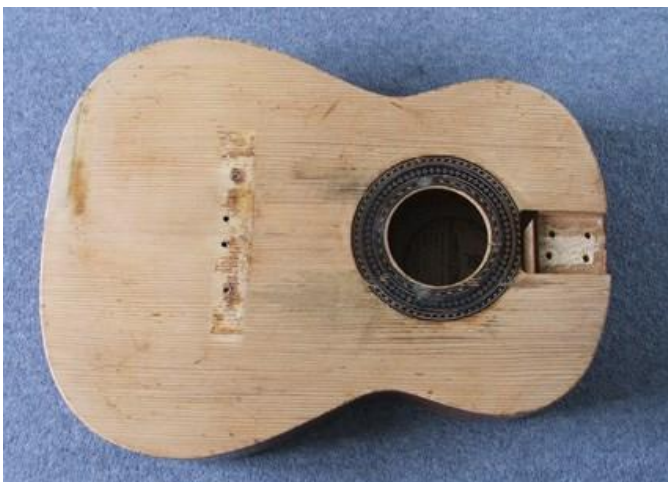
Photo 10.

After sanding, the deeper scratches and heavily worn areas are still visible. To be rid of them completely I would have taken the top down too thin & probably right through the upper lamination.

Having released the clamps I then sanded the top down ready for re-finishing with stain and French polish.

I could have made a complete new top, but that would have changed the appearance and sound of the instrument quite drastically, well beyond my brief.

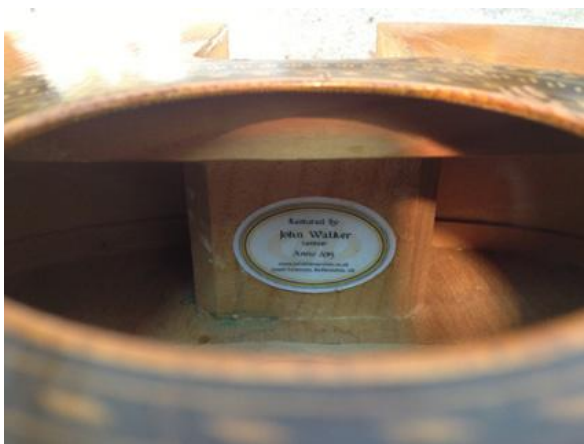
Photo 13.

Because of all the imperfections in the top I didn't want to create a high gloss finish. That would have highlighted them even more. On the back & sides I just rejuvenated the existing polish by rubbing it over with spirit before buffing it up with a lint-free cloth.

Now it was the time to stick my little label inside and then apply the finishing.

Firstly I applied some stain to the patched area to colour-match the new wood with the old, and then applied a further coat to the entire top.

Once the stain had dried I then applied the fading-up coats of French polish along the grain. This was followed by a further 4 bodying-in coats and left to harden for a while and then the surface was lightly rubbed with fine sand-paper. I repeated the bodying-in process before finally spiriting-off with a 50/50 French polish/methylated spirits mix.
