A 1960s Gibson Country Western model came in for repair. It had fallen off a stage and suffered quite a lot of damage.

JW Luthier Services

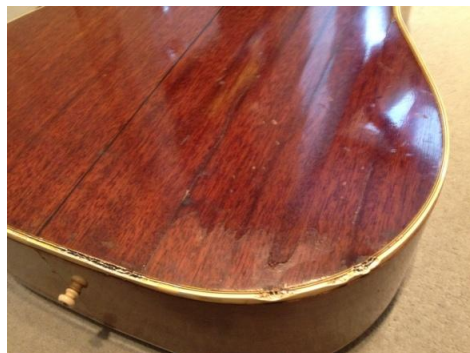
There was quite extensive visible damage to the back and looking into the soundhole I could see that internally there were some broken braces. The binding around the back also looked as though it had been burned and had melted in places.

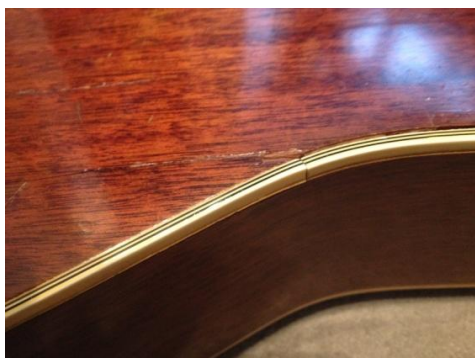
Using an inspection mirror & light through the soundhole it was possible to see that someone had attempted a d-i-y repair by smothering epoxy (?) adhesive all over the inside to try and hold all the breaks together.

Before the adhesive had set it became covered in dirt and dust which made it look even more of a mess.

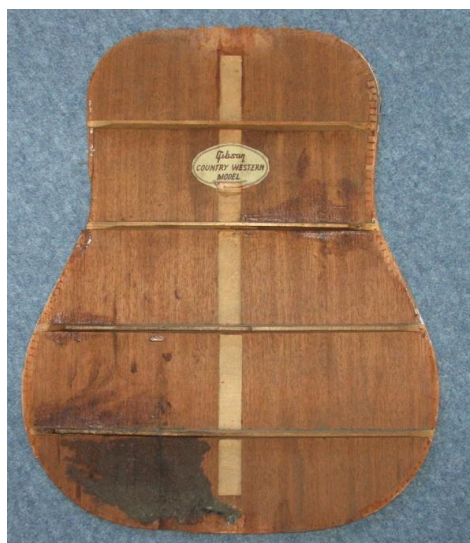
With the back finally off I could see the extent of the damage. There were 8 splits & cracks in the back and 3 broken back braces.

There were also 2 broken braces & 1 detached tone bar on the top.

Some of the kerfed linings were detached & a 200mm section was broken in many pieces.

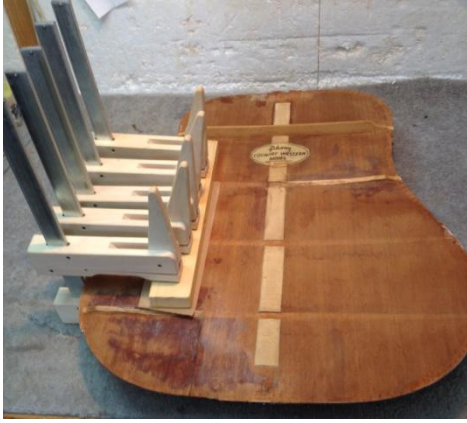
One of the worst aspects of the job was cleaning out the epoxy adhesive from the previous repair attempt. It had been smothered over, and into, most of the breaks and was holding them apart rather than together.

Before I could close up and re-glue the splits I had to spend a lot of time melting the epoxy with acetone and carefully scraping it out back to clean wood.

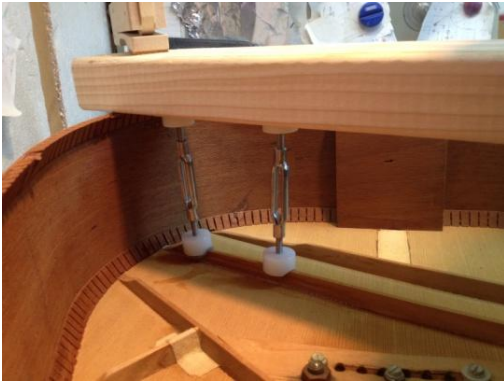
Now it was time to tackle the loose and broken top braces. Usually these are a pain. Access is normally through the soundhole and you are working blind by feel only.

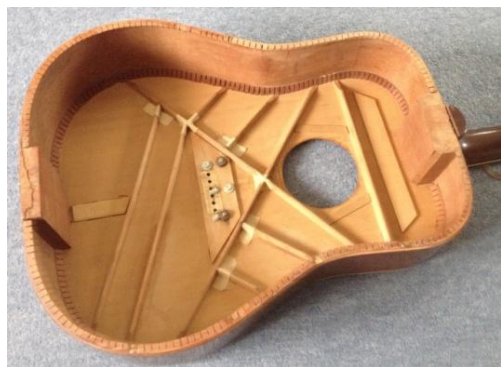
Some of the kerfed linings (which support the back to the sides) had detached and required gluing back in place. One section had broken up too badly to be re-used. This required a new piece to be inserted.

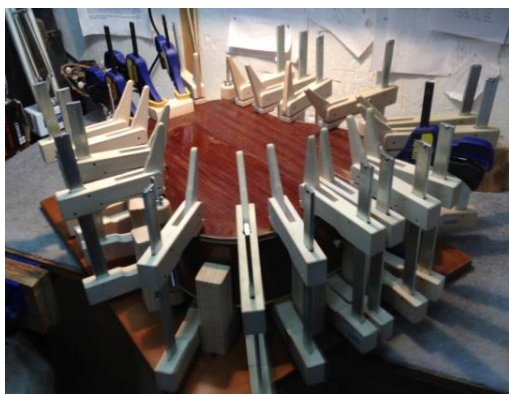
The bridge plate had been damaged around the bridge pin holes and so whilst I had the chance I decided to repair it too.

The bridge plate was made from 3-piece ply and the damage was contained to the top ply only.

I cut out the damaged area and inset a maple insert into the ply. The maple being quite hard should give a better resistance to future wear and tear.
