This Framus archtop was literally coming apart at the seams.

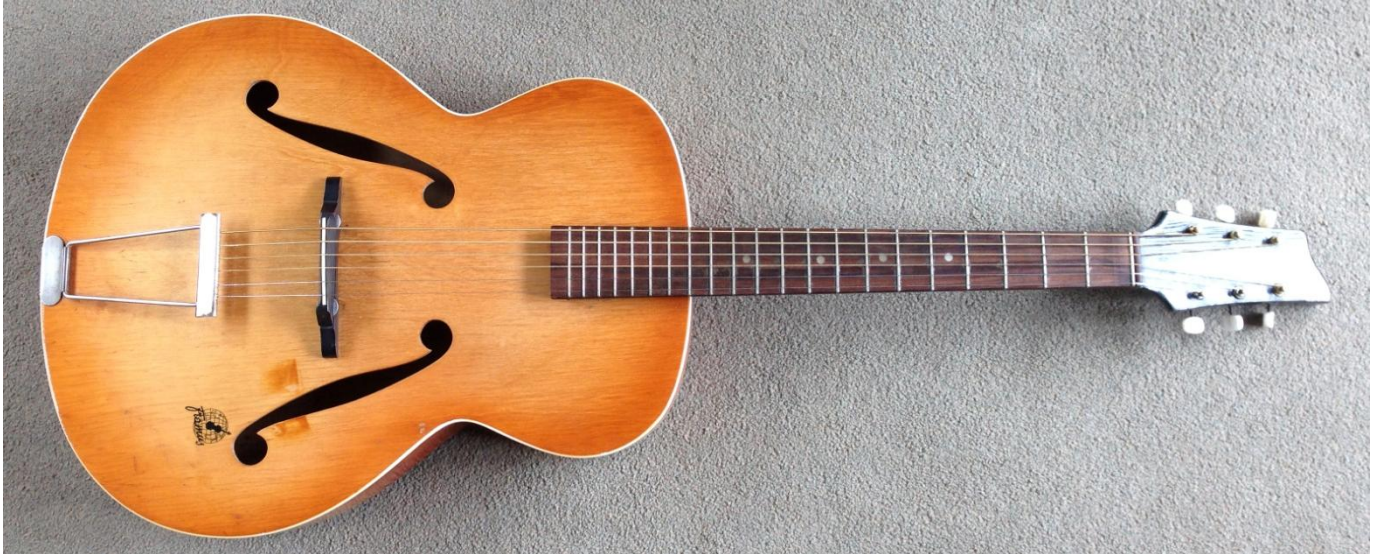
Photo 1:

Serial number 28909-G53 is stamped on the back of the headstock which indicates that it dates from July 1953. Although the last digit is possibly a badly stamped number 8; giving a more likely production year of 1958.

There is no model number or name identified anywhere on it. It looks very much like a 5/50 or 5/51. Originally it had a scratch-guard but that has been lost, leaving only the mounting holes in the side of the neck & body.

At some time it had been fitted with a neck-mounted pick-up. There are witness holes on both sides of the fingerboard where it was mounted & there is a hole for a jack socket in the side of the lower bout.

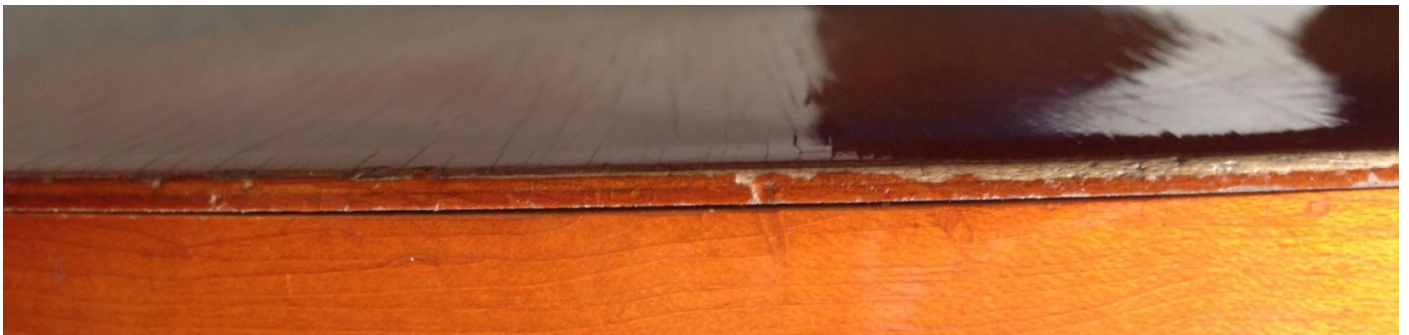
Photo 2: The back was pulling loose most of the way around the body.

The first step was to remove the back to enable the internal repairs.

The back which was already detached around most of its periphery came off quite easily. A hot knife loosened most of the remaining glue & just a little blast with a steam jet dealt with a couple of stubborn areas.

The guitar was then placed top-side down into a holding fixture so that the back could be glued on. A total of 30 clamps were employed to keep the back in place whilst the adhesive cured overnight.

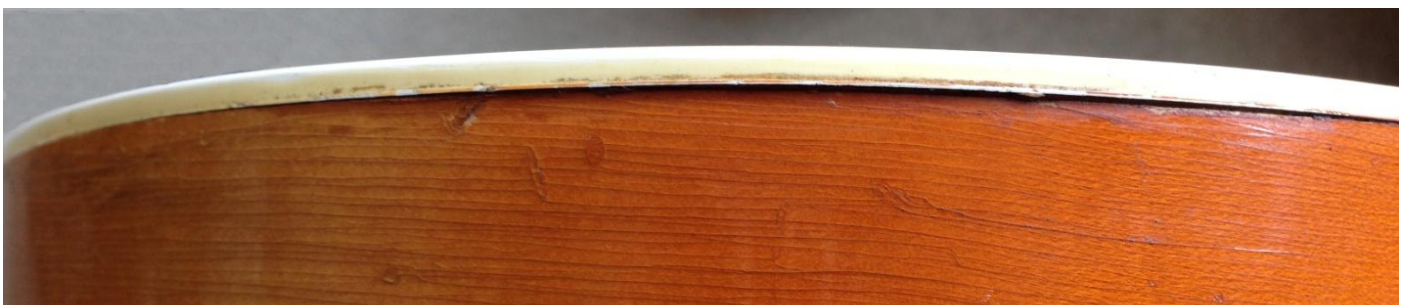
Photo 3: The front & binding had lifted around the lower bout.

Photo 15:
The next step was to re-attach the top to the sides where it had come adrift. The open joints were first cleaned of glue remnants by scraping them out with a hot knife & then some sandpaper. The side had sprung inwards where the joint had failed so required some method of pushing it back into place before gluing. A wooden strut was clamped to the brace & through the F-hole. Then a small jack clamp was used to adjust the side to align properly with the top. Hide glue was applied to the joint & a dozen clamps held it all in place.

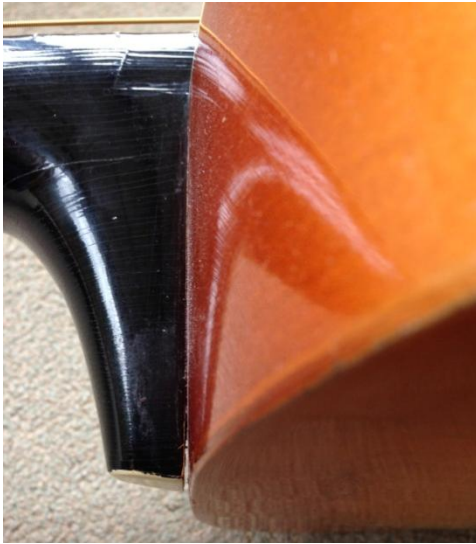
Photo 4:
The neck heel had shrunk back from the body leaving a gap at the end of the heel.

Photo 16:
The neck heel required shimming to plug the gap caused by shrinkage. The neck joint itself was still tightly adhered & stable so didn't need any further attention. A tapered shim about 15mm long was pressed into the gap & glued in position.

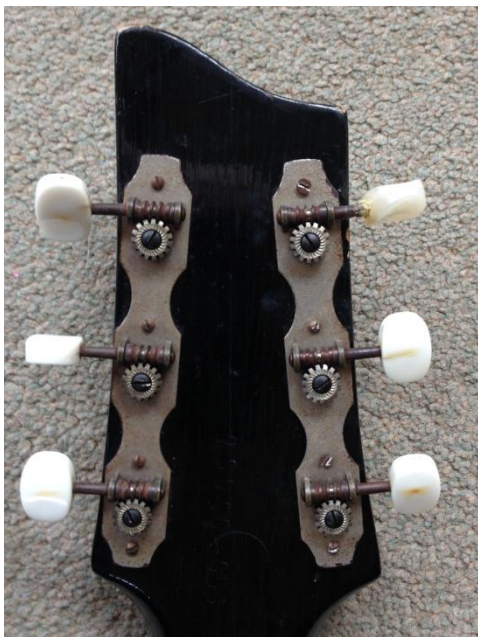
Photo 5:
The tuners worked but some were quite stiff to turn & others were bent. Also some of the knobs were splitting.

Photos 19 & 20: A new set of Framus vintage nickel tuners with oval-pearloid knobs were fitted to replace the bent & rusty old ones. These are an exact replica of the originals & are a perfect fit with the original fixing holes.

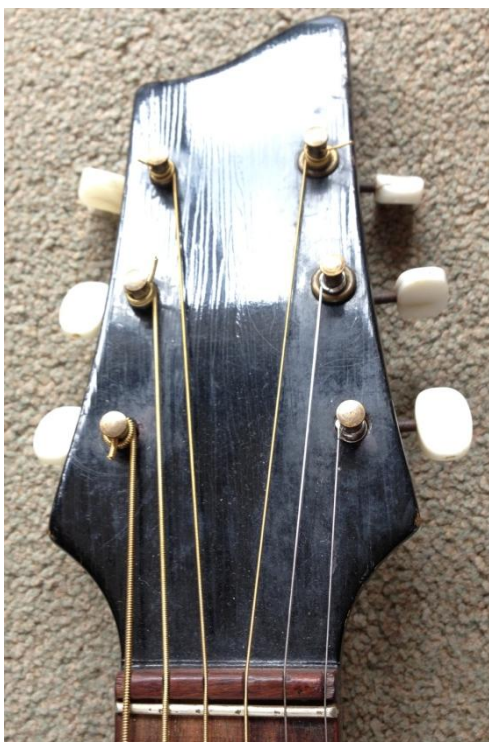
Photo 6:
Only 2 of the tuners had their bushes.
The others had no support & so the pull of the strings was deflecting the shafts & causing the holes in the head to be worn out of shape.

Notice also that the rosewood string-nut has broken away at the ends allowing the E-strings to slip off the zero-fret during play.

The old damaged string-nut was carefully knocked loose & then the frets were levelled & dressed.

A new nut was crafted out of a piece of rosewood & fitted in place. The string spacing was kept identical to the original.

A new set of tuner bushes were pressed into the head to support the string spigots. The holes needed reaming out slightly as these were a marginally larger external diameter than the originals. That was an advantage because the original holes had been worn out of shape due to the missing bushes.

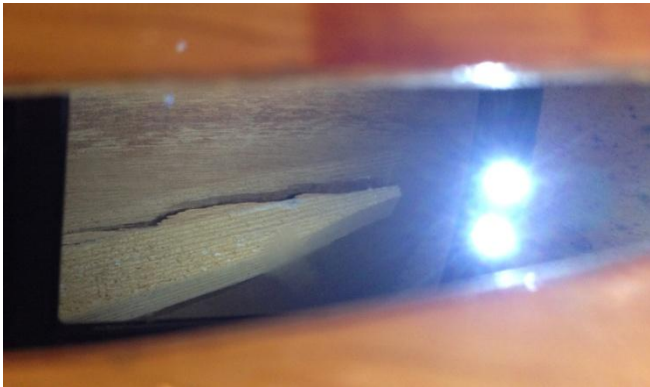
With the aid of an inspection mirror inserted through the F-holes it was possible to see that the two top braces had failed. See photos 7 & 8.

Photo 7: A broken brace.

To ensure good adhesion both braces were removed & then re-attached with hide glue. It was convenient to use 6 clamps & wooden clamping cauls to hold the braces securely in place whilst the adhesive cured.

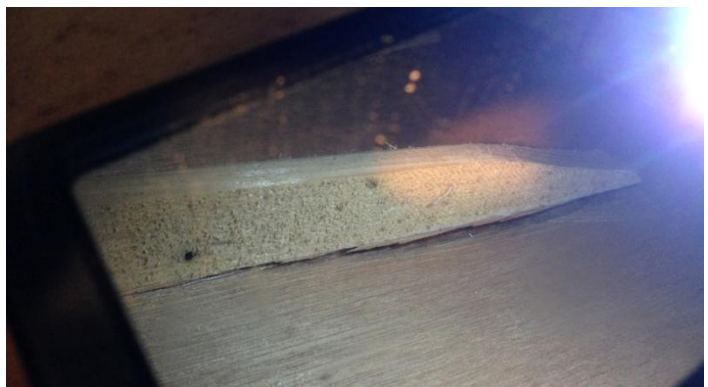
Photo 8: The other brace detached from the top.

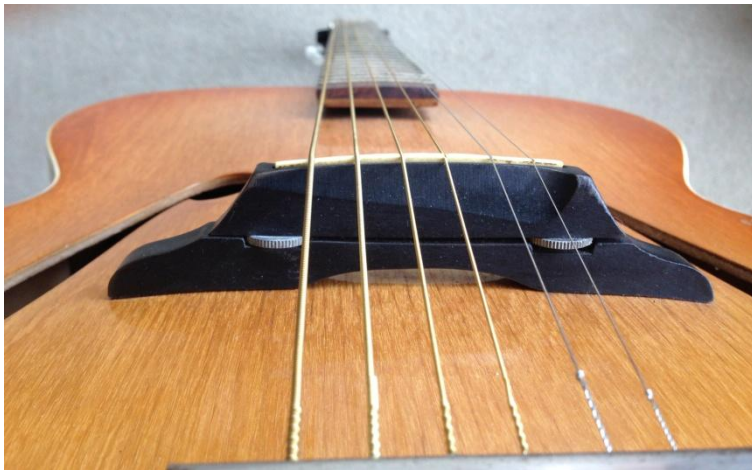
Photo 9:

The bridge was set down as low as it could go but the string height over the 12th fret was at a massive height of 4.6mm.

The neck was remarkably straight. Despite not having a truss-rod there was just the correct amount of neck relief & the fret-board, although very dirty was also in good condition.

The frets were not very level & showed some wear on the first 5 positions.

The repairs to the body & top braces had pulled the action down somewhat but it was still greater than desired even though the bridge was adjusted as low as it could go. Therefore the bridge height had to be reduced. To keep the proportions balanced the height reduction was split between the two bridge sections. 2mm was taken off the bridge feet & 2mm off the bottom surface of the top section.

The new bridge height gives an action of 2.00mm at the 12th fret with enough scope for up & down adjustment.

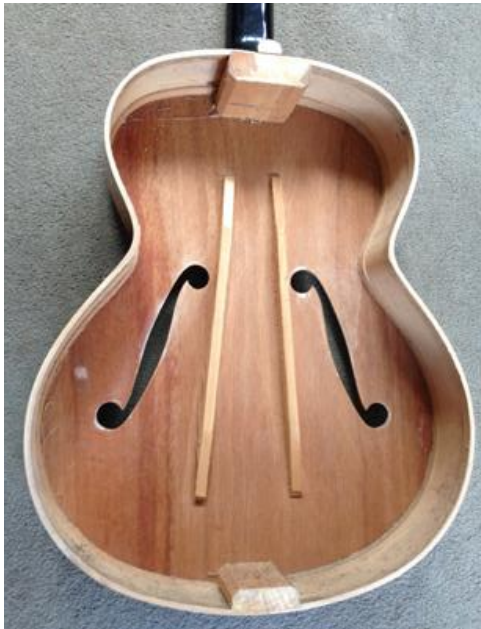
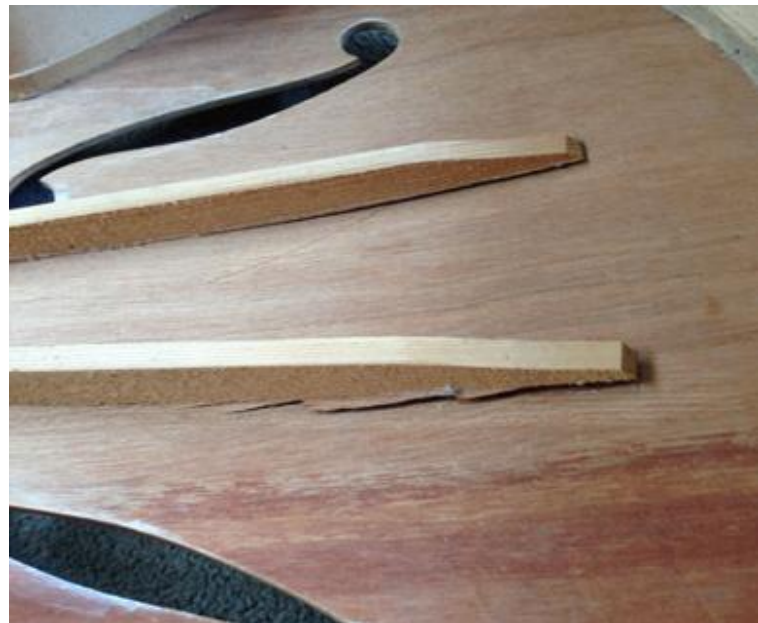
Photos 11 & 12: With the back off it was possible to assess the damage to the braces. One of them just had a failure of the glued joint but the other had partially ripped the surrounding surface. Both relatively easy to resolve.

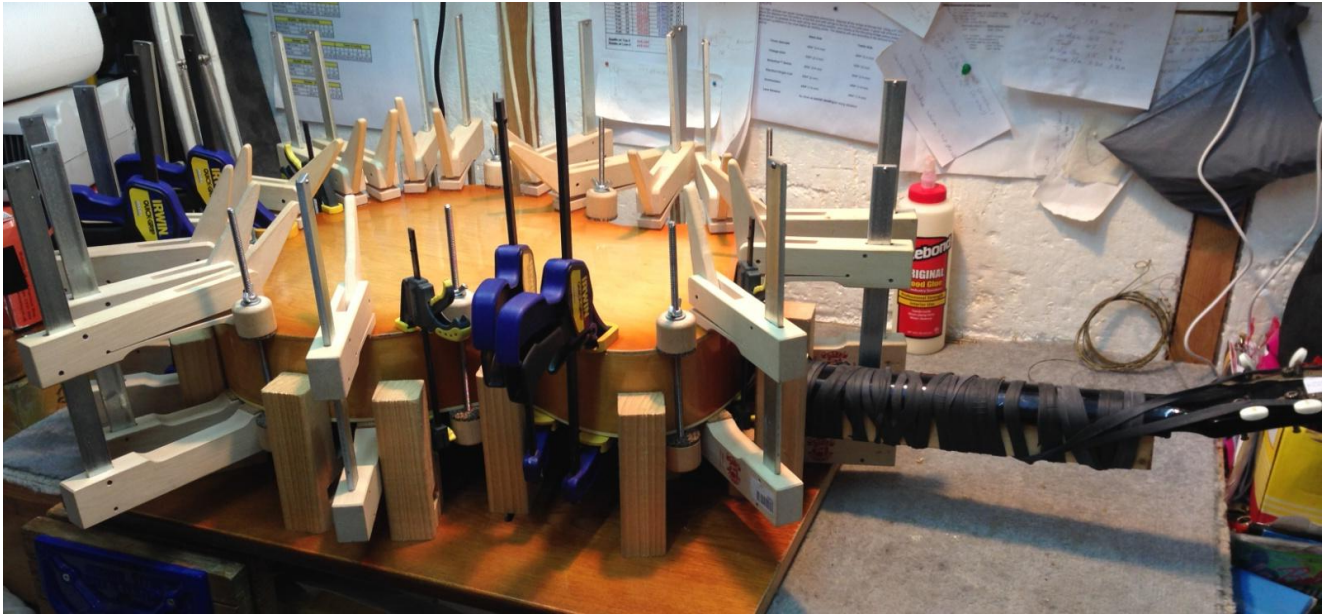
Photo 17: Re-attaching the back presents a slight challenge.

The body is only rigid when all the components are firmly attached. Until then the sides are able to flex which allows the neck to wave around somewhat.

To ensure the neck gets set at the correct height & alignment to the top it must be firmly held in position whilst the back is being re-glued.

A long beam was put over the fretboard & held in place with strong elastic strapping. The required projected height of the frets at the bridge position was calculated & a correctly sized block was placed under the beam, located at the bridge position. A clamping arrangement held it firmly to the guitar top & also set the neck to align with the body centreline.

The back & sides aligned quite accurately & only a minimal amount of trimming was necessary to smooth them in.

This guitar never originally had any binding around the back & so it was left as it was without any. A touch-up to the lacquer around the edge of the back blended it all in.
