A 1960s Gibson Country Western model came in for repair. It had fallen off a stage and suffered quite a lot of damage.

JW Luthier Services

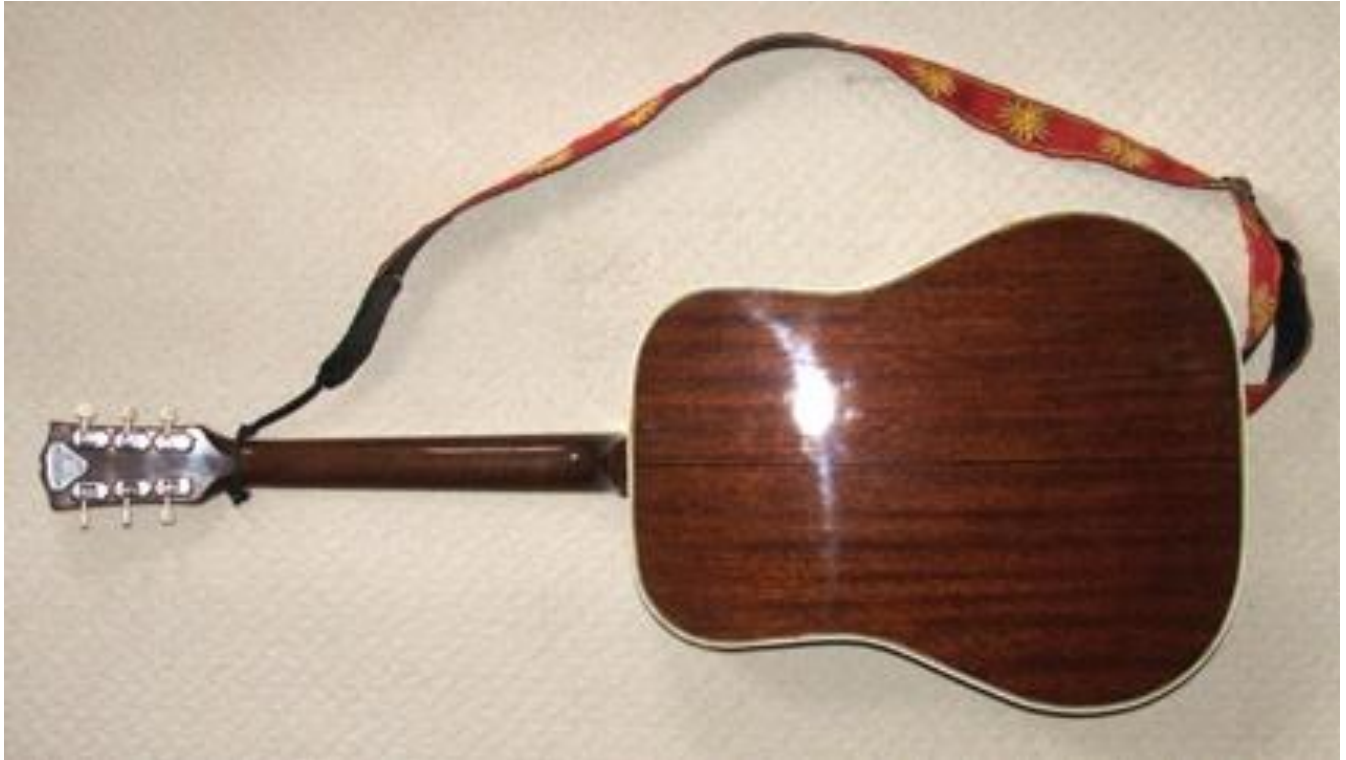
And here is the finished instrument with 15 coats of French polish on the back.
Looking and sounding exquisite, just like a Gibson Country Western should !
